# APPLIED APPROACH SLAB SETTLEMENT RESEARCH, DESIGN/CONSTRUCTION

FINAL REPORT ~ FHWA-OK-13-09  
ODOT SP&R ITEM NUMBER 2227

Gerald A. Miller, Kianoosh Hatami, Amy B. Cerato, Colin Osborne  
School of Civil Engineering and Environmental Science  
University of Oklahoma

August 2013

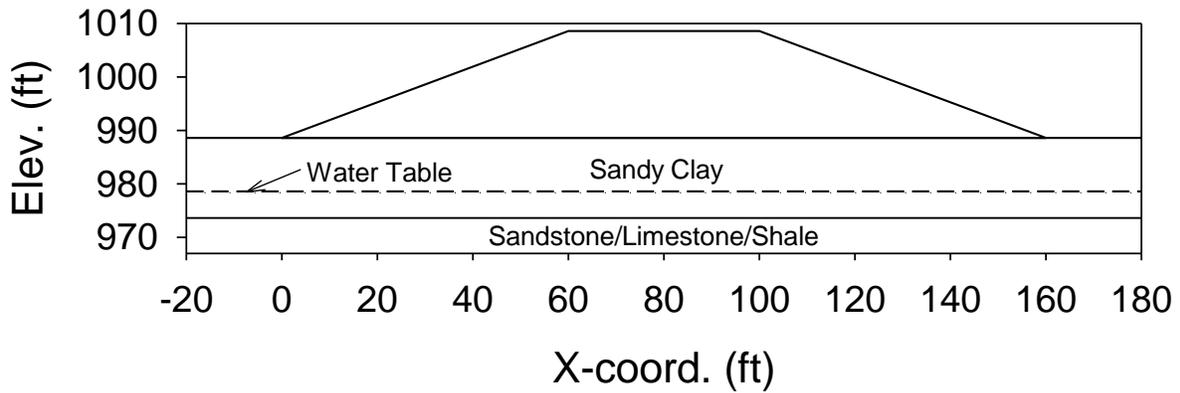
**Figure 5.40 Embankment Geometry and Soil Profile Assumed for Settlement Analysis – SH-1 over SH-99**

Based on the preceding discussion, for the purpose of analyzing the settlement of the foundation soil a thickness of 15 feet was assumed below the east embankment. Consolidation test results are presented in Table 5.9 and Figure 5.39. The assumed embankment geometry and soil properties used in the analysis are shown in Figures 5.40 and Figures 5.41. Settlement parameters used for the analysis, shown in Figure 5.41, are based on the average values representing natural soils below the embankments corresponding to borings BH-4, BH-5, and BH-6 in Table 5.9. These parameters are consistent with other Oklahoma soils as shown in Figures 5.5 and 5.6, although recompression parameters for the higher PI soils are higher than noted for other sites. It should be noted the higher recompression indices were obtained from unload-reload curves for these particular higher PI soils.

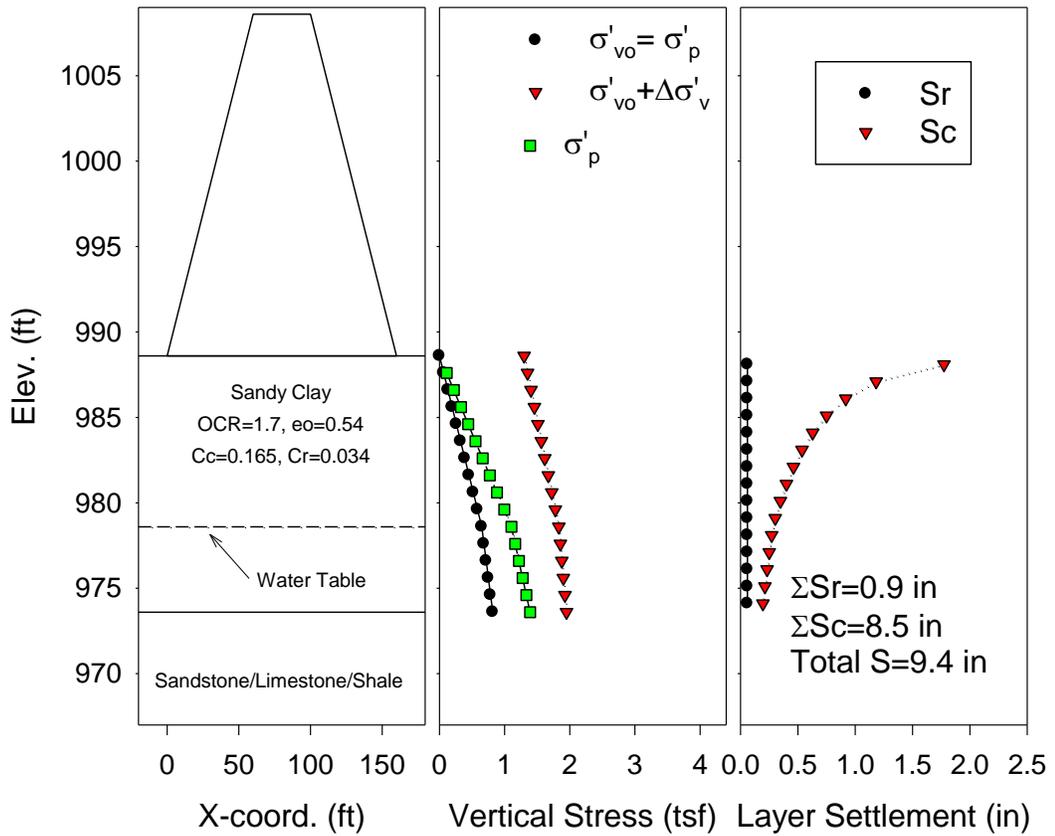
**Figure 5.41 Results of Settlement Analysis – SH-1 over SH-99**

Results of the settlement analysis predict a total settlement of 9.4 inches, being mostly due to virgin compression. Estimates of wetting-induced compression settlement based indicate a possible collapse settlement of about 0.4 inches for complete wetting of a 20-foot thick embankment. Wetting-induced compression was calculated based on the double-oedometer results shown in Figure 5.42 for a sample compacted to about 97% relative compaction and 2 percentage points dry of the OMC based on the standard compaction curve shown in Figure 5.43. Since wetting-induced collapse is only expected to occur in the lowest 5 feet of the embankment and collapse strains in the corresponding stress range are relatively small, predicted collapse settlements are relatively low for this fill. Results of the settlement analysis suggest the
